Draft Environmental Assessment

Reconstruction of the Monte Cristo Grade Road

Snohomish County, WA
FEMA-1499-DR-WA (Public Assistance)
April 2005

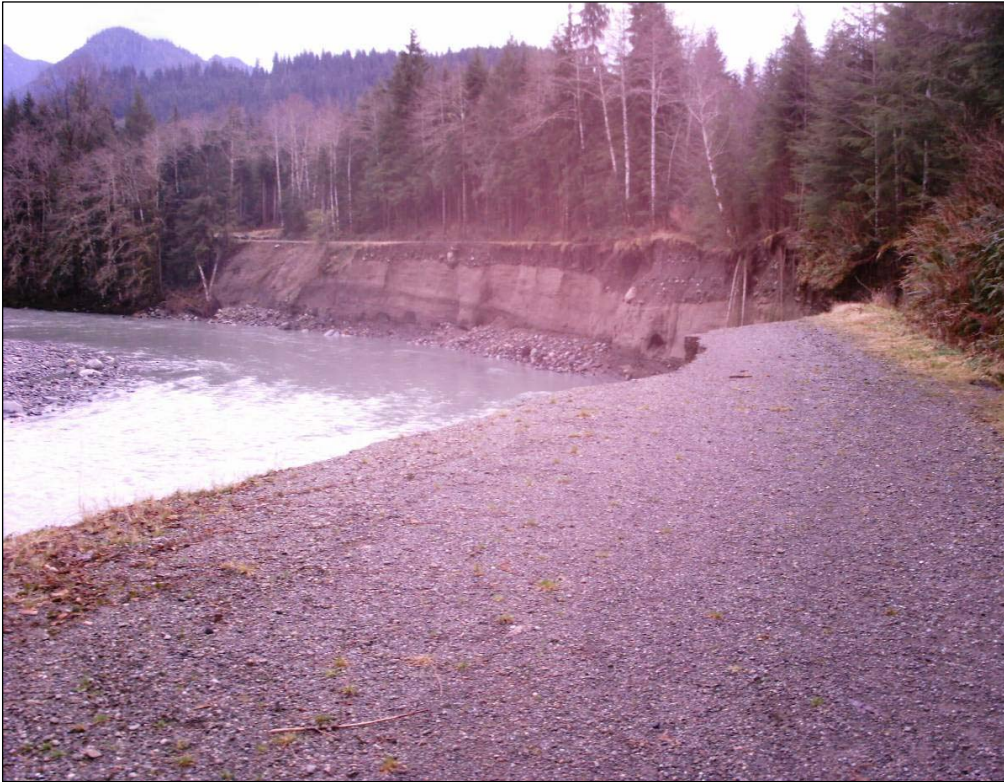
Photo 1. Monte Cristo Grade Road wash-out looking upstream.

The Monte Cristo Grade Road wash-out is located on private property at approximately River Mile (RM) 47.2, along the southern, or left bank (facing downriver), just outside the town of Verlot in Township 30N, Range 8E, Section 15 (Figure 1-1). The road wash-out is located about 0.1 mile from the intersection with Pilchuck Mountain Road (USFS Road #42), which meets Highway 92 (the Mountain Loop Highway) just east of a major bridge (Photo 1). It is estimated that the flood flows reached an elevation of 984 ft at the wash-out site, which is approximately 10-12 ft above the low-flow river levels (Van Wormer 2005). The high flow undermined the mostly unconsolidated hillside upon which the road was located. The 2003 flood removed 40 to 60 ft (horizontal distance) of the riverbank, which amounted to 30,000-40,000 cubic yards (cy) of sand, gravel, and cobble (Van Wormer 2005). Snohomish County has installed concrete barricades near

the intersection with Pilchuck Road to prevent vehicular access. Approximately 2 miles of road is isolated by the wash-out. Currently, residents must walk around the wash-out to reach their properties. The adjacent land is privately owned; USFS administered land in the Mt. Baker-Snoqualmie National Forest is located immediately south of the project location.

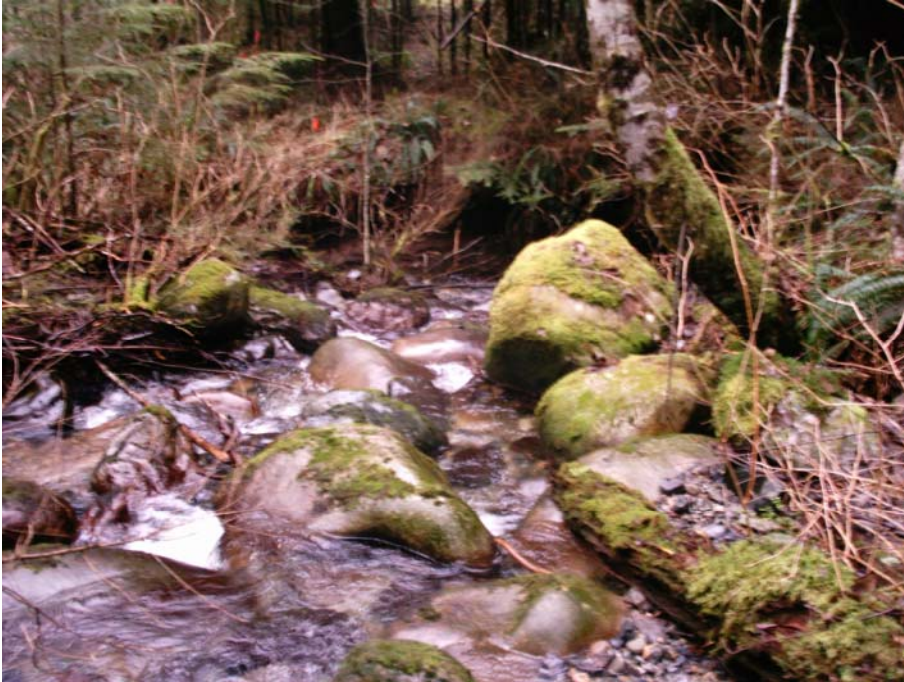
Photo 2. Unnamed stream that flows through the project site.

The unnamed stream at the site (see Photo 2) is fed by three small tributaries and numerous seeps along the lower slopes south of the creek. This stream had approximately 6 cfs flow at the existing Monte Cristo Grade Road during a January 2005 site visit. The active channel width varied between 3 and 10 ft. The presence of a 48-inch diameter culvert under the Monte Cristo Grade Road may indicate the need to accommodate occasional high flows. Each of the three small tributaries that flow into the stream were contributing 1-3 cfs. Many seeps also feed into the stream system (wetlands are discussed in greater detail in Section 3.3). The main channel of the unnamed stream meets the DNR Water Typing criteria for Type 3 Waters—those that are more than 2 feet in width (bankfull width) and have a moderate to slight fish, wildlife, and human use (WAC 222-16-031). The smaller tributaries that flow into the stream are probably Washington Department of Natural Resources (WDNR) Type 4 Waters—permanent, non-fish bearing stream—but additional field verification would be necessary. In terms of Snohomish County criteria, the stream is a Type 4 stream, while the three small tributaries meet Snohomish County criteria for Type 5 streams.

In addition to the large culvert for the stream system, a roadside ditch along the southern side of the road is drained by a 24-inch diameter culvert under the road near the eastern end of the eroding bluff. A roadside ditch also extends from the existing stream crossing

for several hundred feet to the west and connects with a large scrub-shrub wetland between the road and the slopes to the south.
